# YOUR INSPECTION REPORT

**FOR THE PROPERTY AT:**  
123 Sample Dr  
Pleasant Plains, AR 72568

**INSPECTION DATE:**  
Tuesday, September 15, 2020

RE: Report No. 1041, v.2  
123 Sample Dr  
Pleasant Plains, AR  
72568

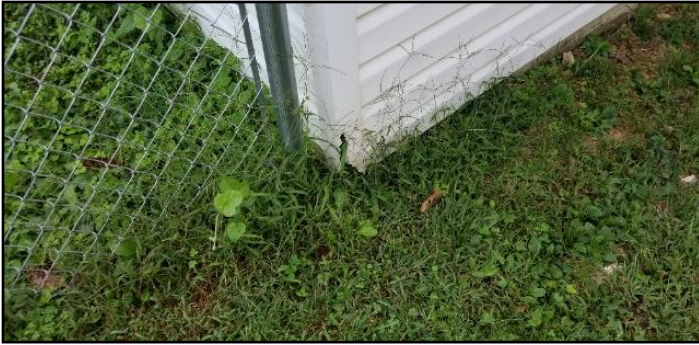
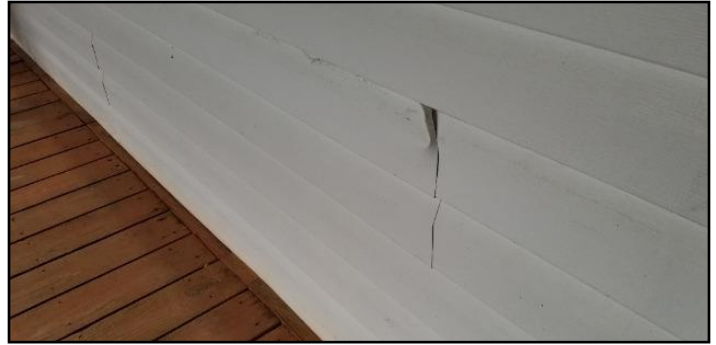
**Condition:** • [Mechanical damage](#)

*Mechanical damage*

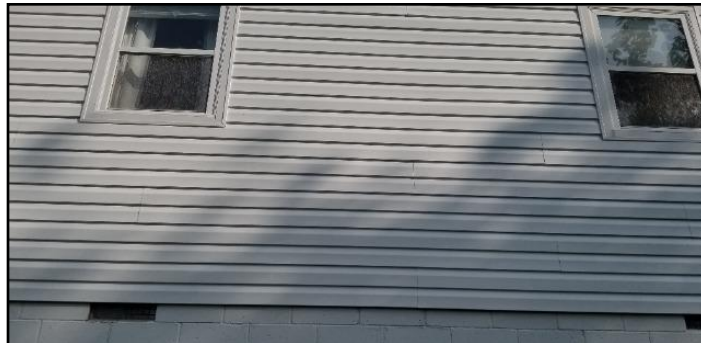
**Condition:** • Paint and Caulking - deteriorated / missing

*Paint and Caulking - deteriorated / missing*

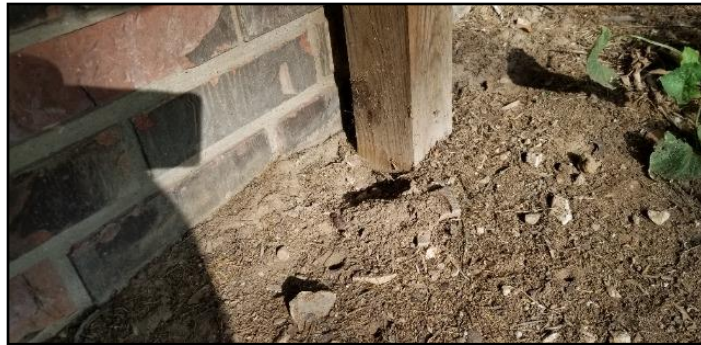
**Condition:** • [Wood/soil contact](#)

This will lead to damage of the components.

*Wood/soil contact*

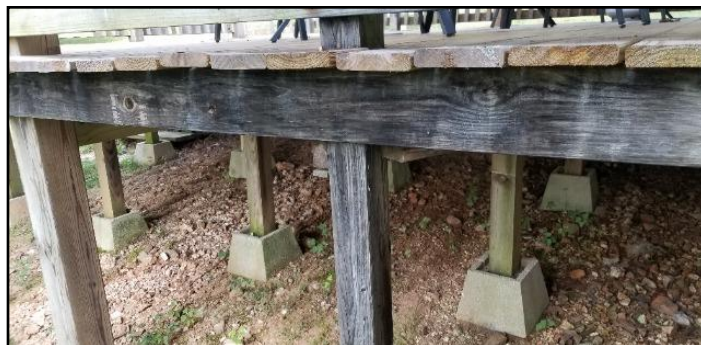
**Condition:** • The rear porch is in need of cleaning and resealing to prolong its life. Otherwise it will begin to deteriorate. I suggest doing this sooner rather than later. This also applies to the roof structure.

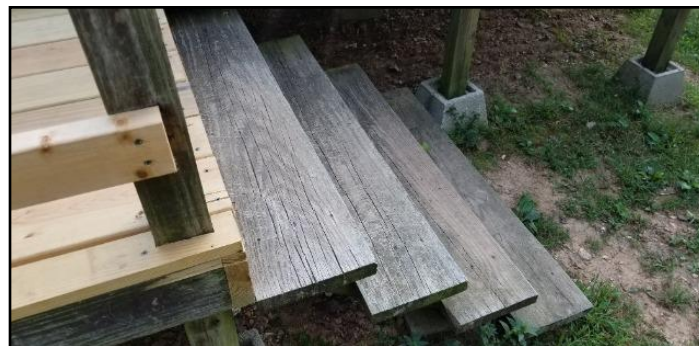
**Condition:** • [Missing](#)

*Missing*

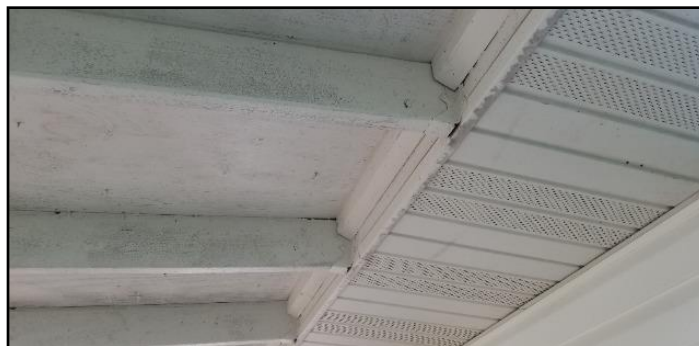
**Condition:** • Ideally we want the roofing system attached to the trusses or rafters, not the fascia board.

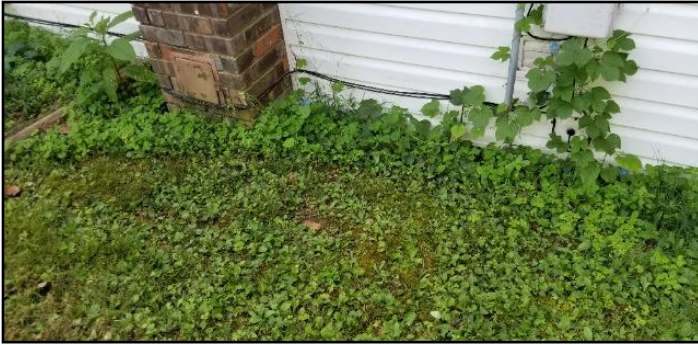
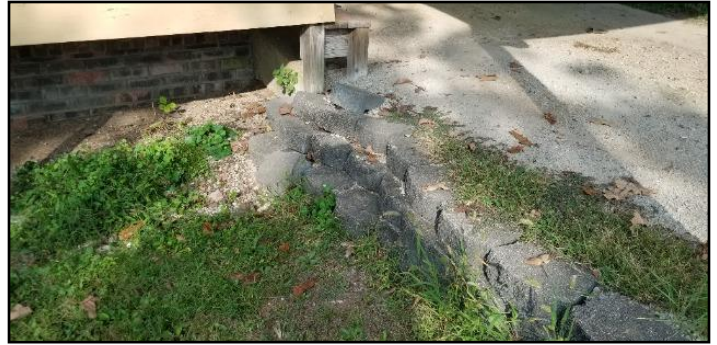
**Condition:** • [Improper slope or drainage](#)

*Improper slope or drainage*

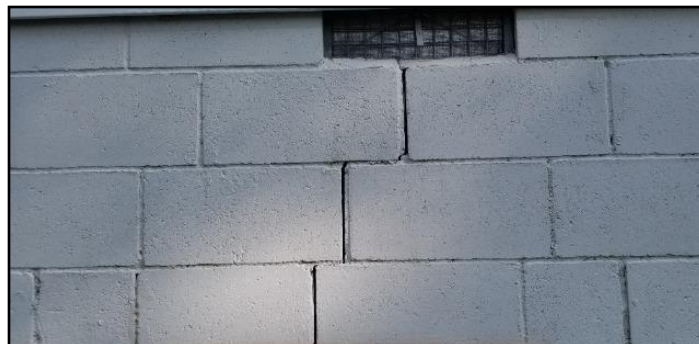
**Condition:** • [Typical minor settlement](#)

Arkansas has a high clay content. So the soil moves a lot. Keep an eye on these cracks making sure they are sealed up. The idea is to keep water out.

*Typical minor settlement*

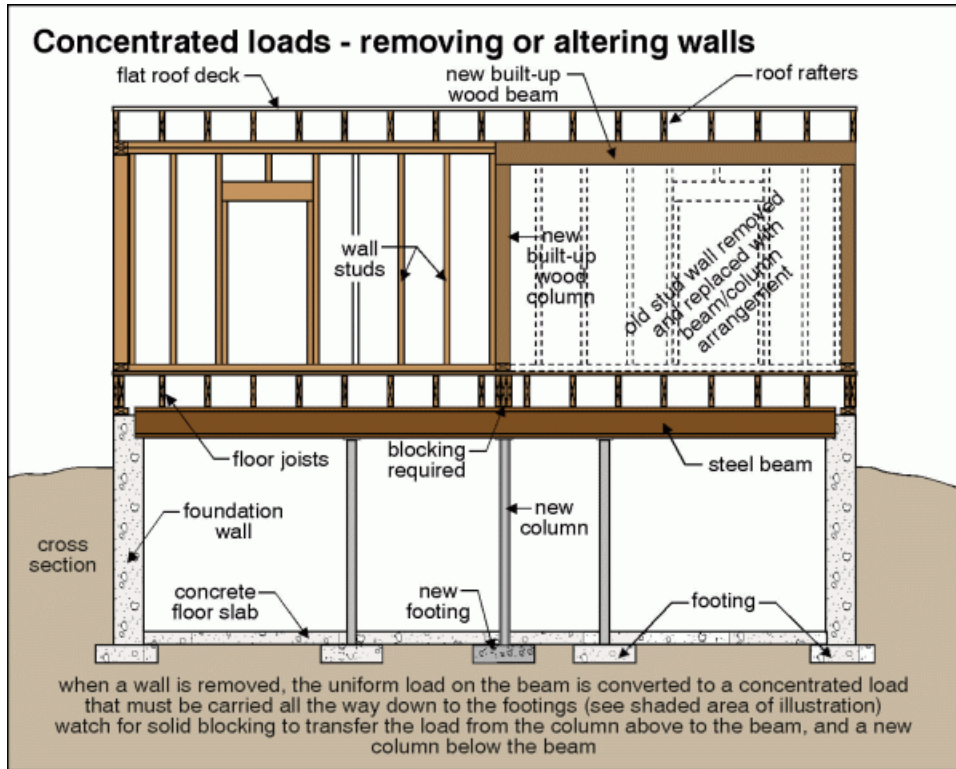
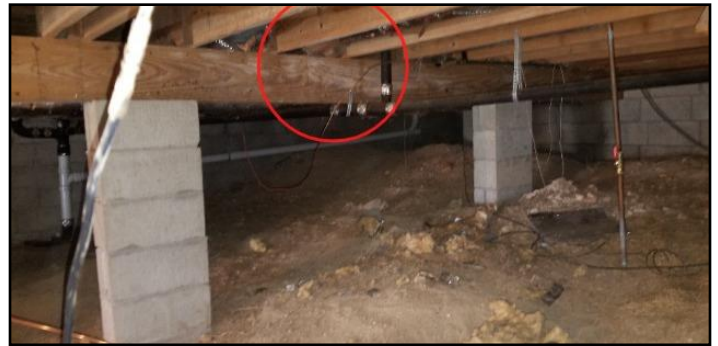
**Condition:** • [Concentrated loads](#)

The removal of the wall in the kitchen looks to have created a concentrated load. I suggest personally inspecting the crawlspace under the wall every year to make sure the foundation wall, and the center main beam are not moving.

Concentrated loads

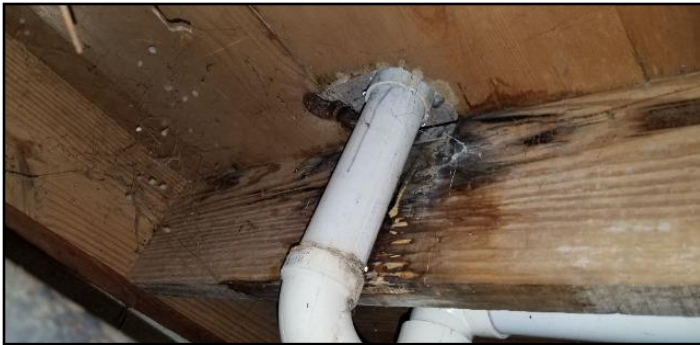
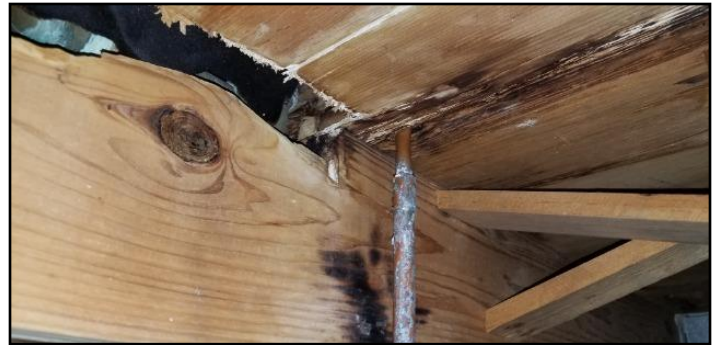
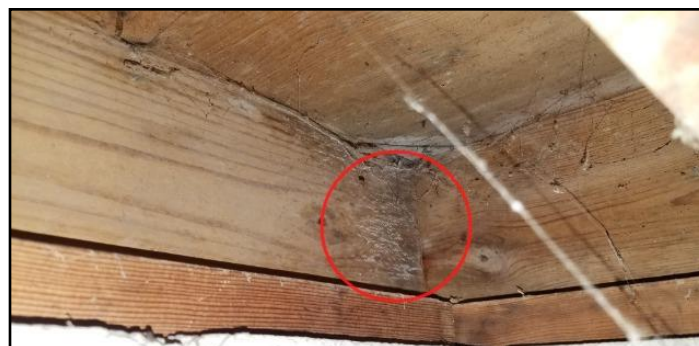
**Condition:** • Affected by Moisture.

These three areas of the joist have been water damaged. Not horribly beyond repair, Steps can be taken to strengthen the wood components and to slow down/ eliminate the deterioration. Including fixing the leaks. I suggest consulting with a qualified contractor.

*Affected by Moisture.*

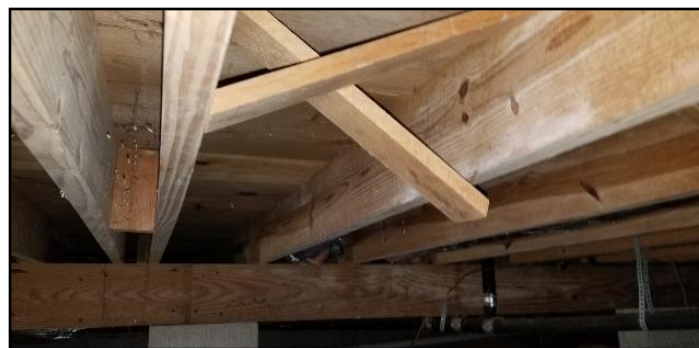
**Condition:** • Broken Cross Bracing.

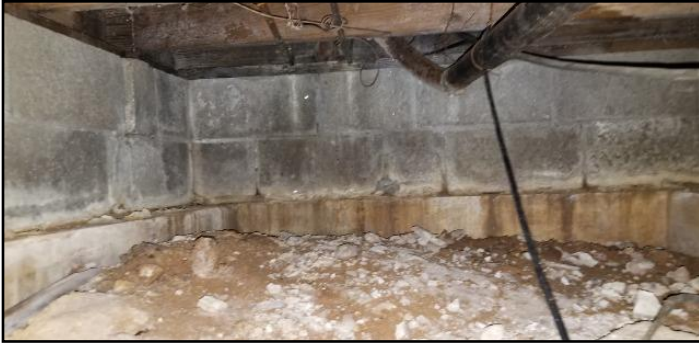
*Moisture against that uphill wall.*

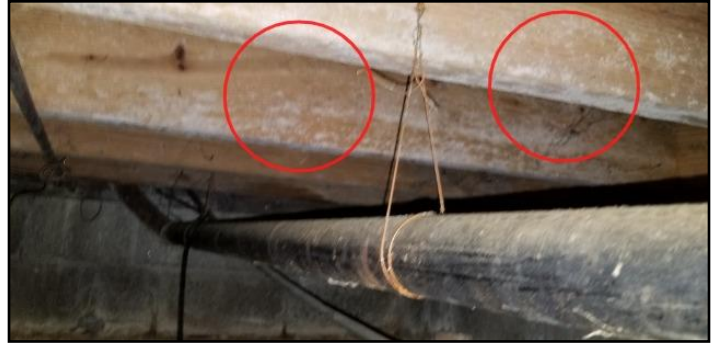
**Condition:** • Mold

I know mold can be scary, its a word we associate with disgust and uncleanliness. However it is quite treatable, especially in this situation. The floor is easy to reach, I do suggest remediation or at least some action to kill and remove the mold in the crawlspace. This is not a bad case of mold, however we want to stop moisture from getting in the crawlspace and the mold from growing.

*Mold*

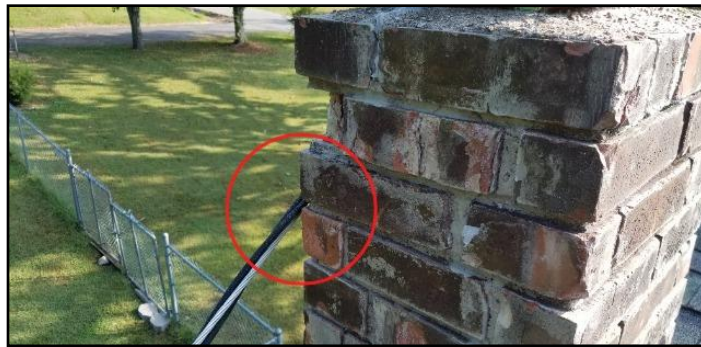
Condition: • [Height over roof](#)

This is not ideal, and can lead to wear of the wire, and electric shock.

*Height over roof*

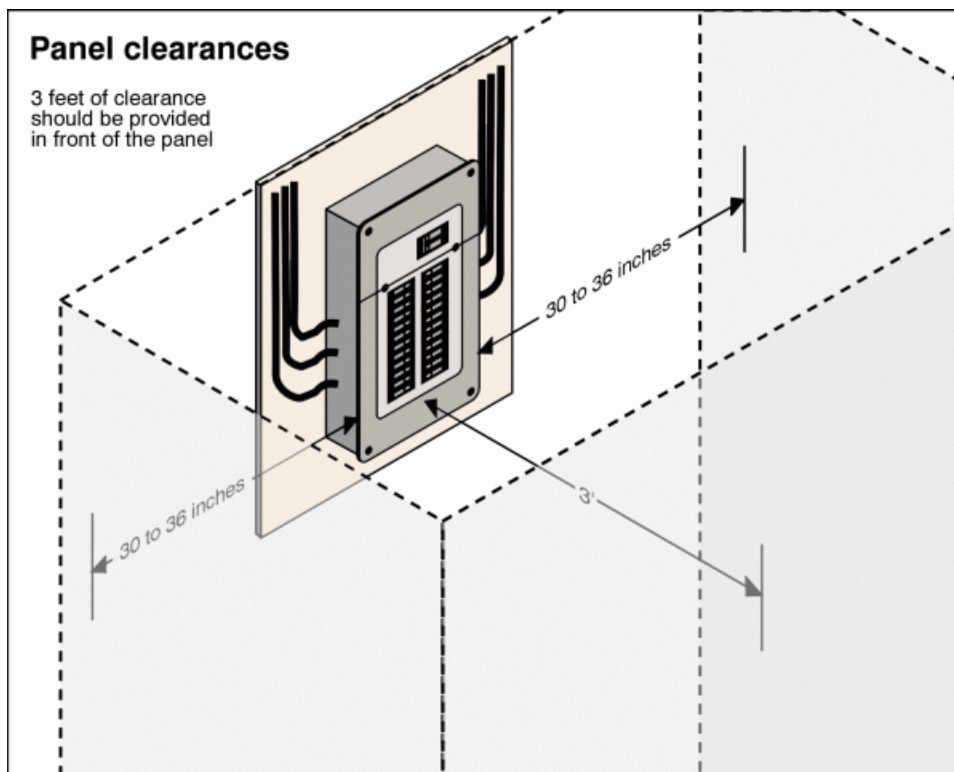
**Condition:** • [Poor access](#)

Poor access

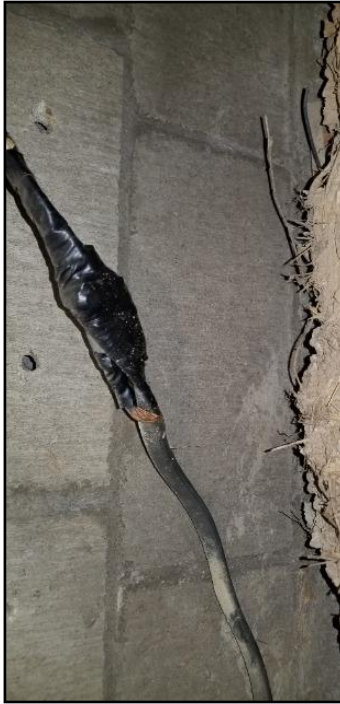
**Condition:** • [Open splices](#)

Here is a poor splice feeding what I believe to be the Range. I suggest having this repair by a qualified electrician.

*Open splices*

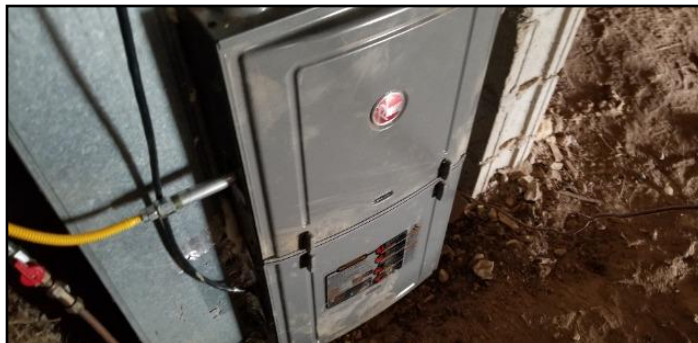
**Condition:** • The furnace is sitting on the ground. This is less than ideal for obvious reasons. I suggest getting a spacer under this beautiful new unit, before it starts to rust.

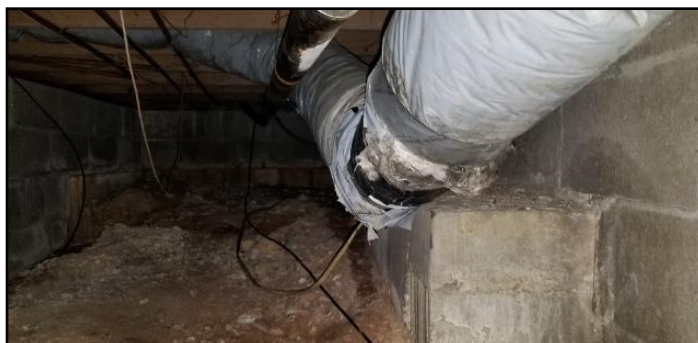
**Condition:** • Damaged. The duct under a leak has been damaged due to water. I suggest repairing or replacing it as soon as possible.

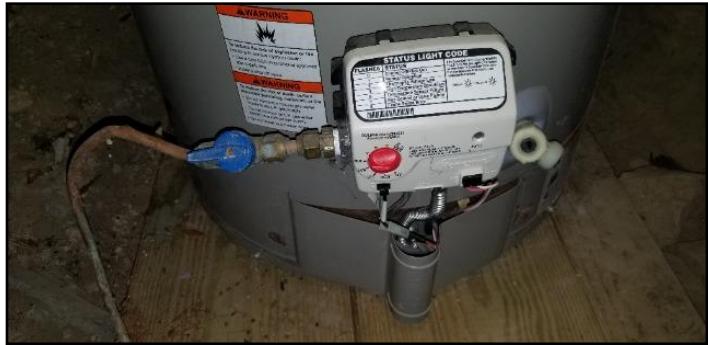
**Condition:** • [No drip leg \(sediment trap, dirt pocket\)](#)

*No drip leg (sediment trap, dirt pocket)*

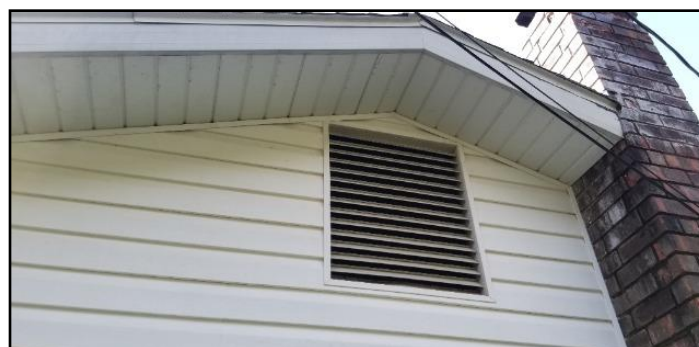
**Condition:** • [Inadequate](#)

*Inadequate*

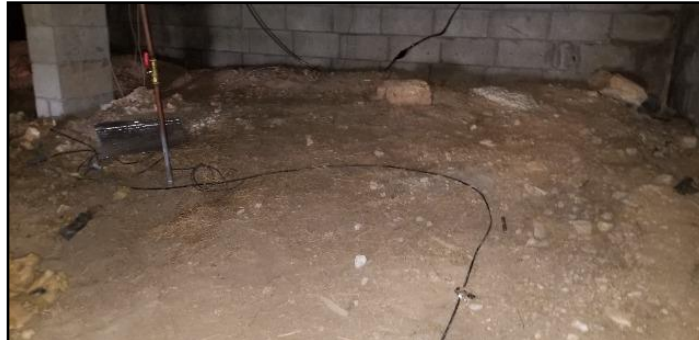
**Condition:** • [No vapor barrier](#)

Not having a moisture barrier is an issue. I highly suggest this is the first thing you install. It will help keep your crawlspace dry.

*No vapor barrier*

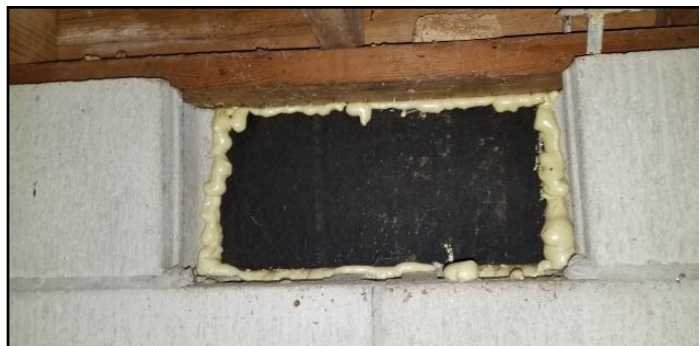
**Condition:** • Inadequate

Im not sure why the vents are sealed. Ideally we open them in the summer and close them in the winter. The home has the potential to have adequate ventilation however they need to be opened up. Whenever the temp is above 60 F. And the humidity is low, keep them open. When its below 60 F and the humidity starts to creep up, shut them.

*Inadequate*

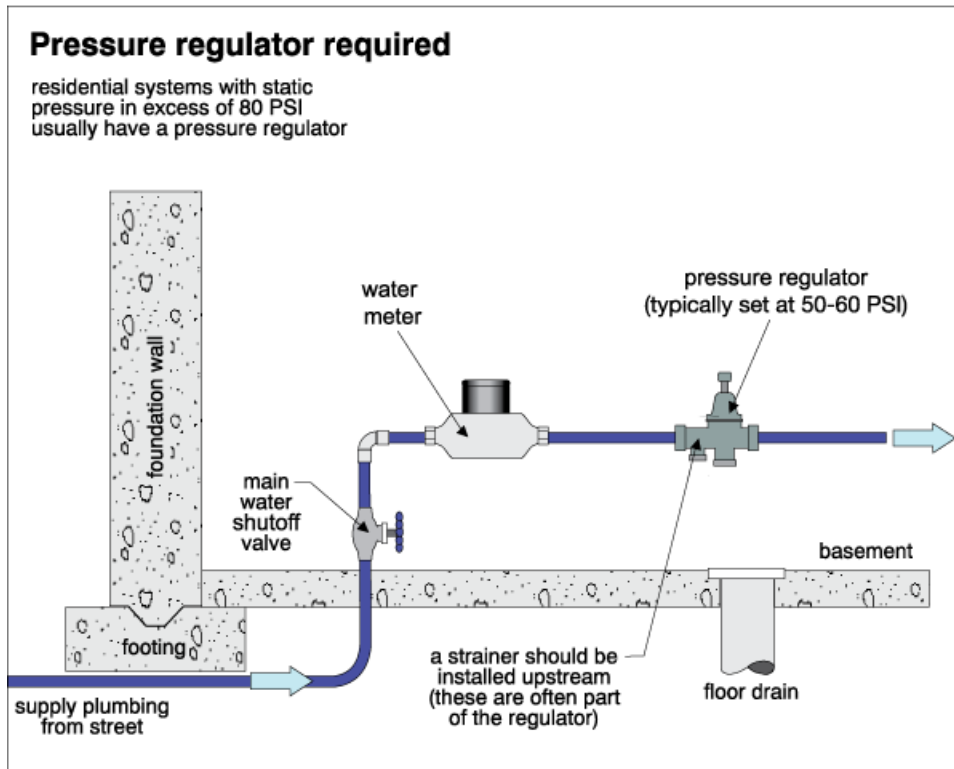
Condition: • Missing

There is no regulator under the house on the main line in. You may find you want one if your connections start to fail, or if the pressure fluctuates a lot.

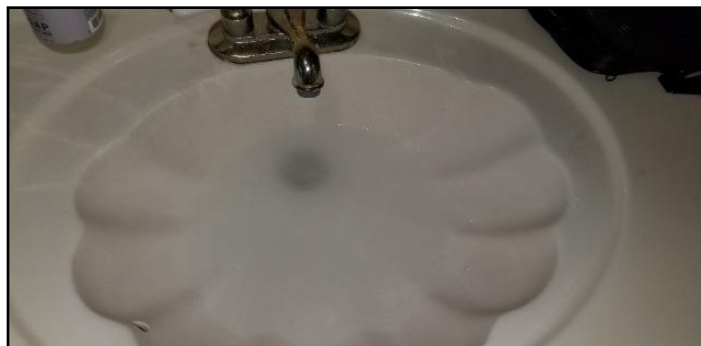
**Condition:** • Slow to drain. This could be a vent issue, or simply clogged.

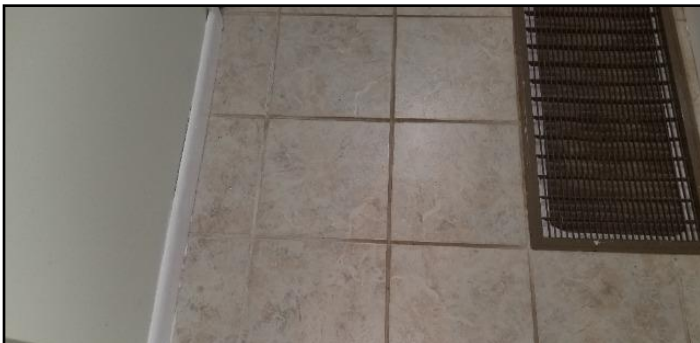
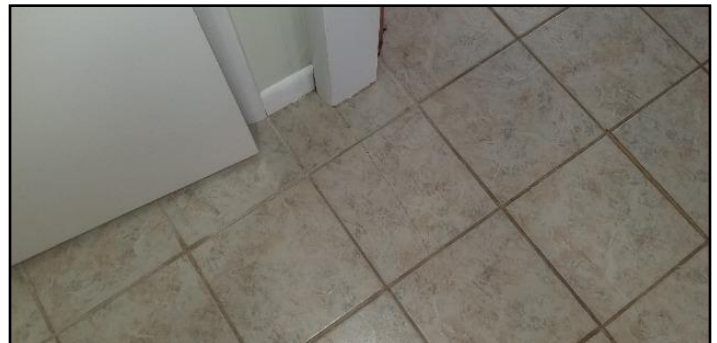
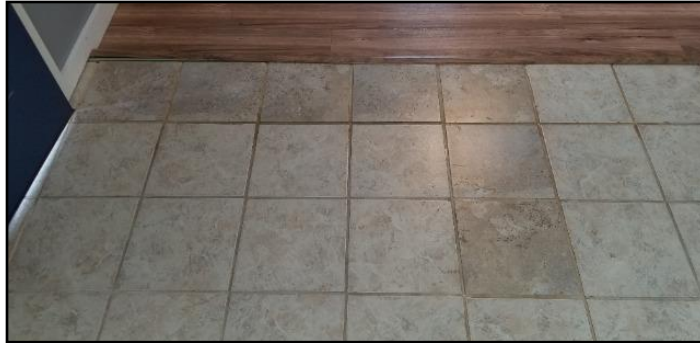
Tiles cracked

*Tiles cracked*
