# YOUR INSPECTION REPORT

**FOR THE PROPERTY AT:**  
123 Sample Dr  
Pleasant Plains, AR 72568

**INSPECTION DATE:**  
Tuesday, September 15, 2020

RE: Report No. 1041, v.2  
123 Sample Dr  
Pleasant Plains, AR  
72568

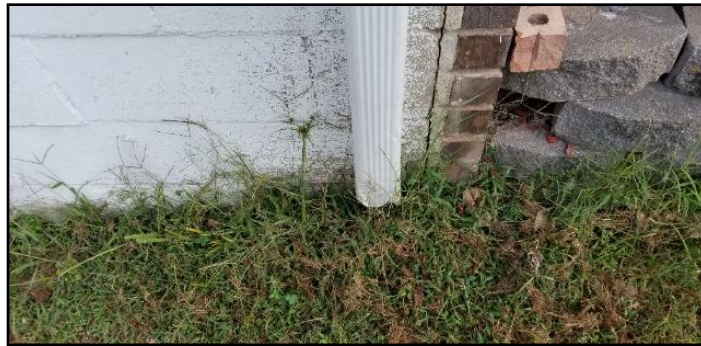
*Should discharge 6 feet from building*
