# YOUR INSPECTION REPORT

**FOR THE PROPERTY AT:**  
123 Sample Dr  
Pleasant Plains, AR 72568

**INSPECTION DATE:**  
Tuesday, September 15, 2020

RE: Report No. 1041, v.2  
123 Sample Dr  
Pleasant Plains, AR  
72568

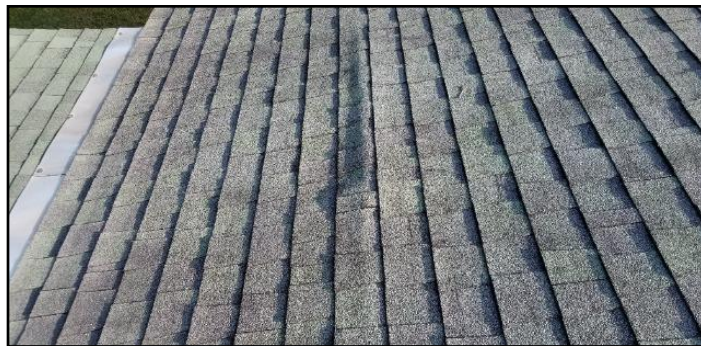
**Condition:** • [Cupping, curling, clawing](#)

As we spoke this is often caused by the expansion and contraction of the decking. Keep an eye on this area, and the small one in the front. If water is going to start intruding in the attic, it will probably be here.

**Implication(s):** Chance of water damage to structure, finishes and contents

*Cupping, curling, clawing*

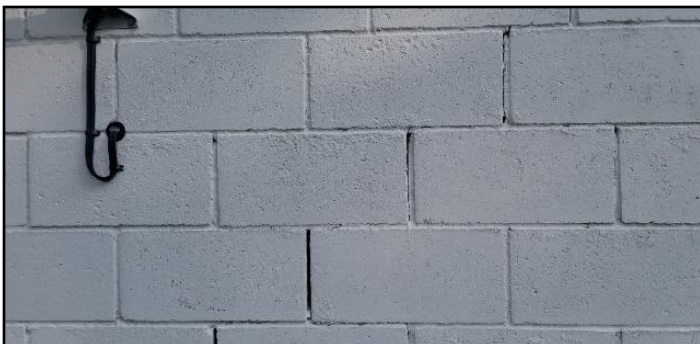
*Typical minor settlement*

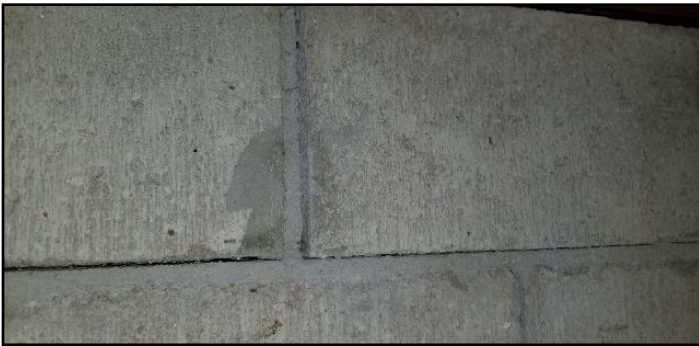
Concentrated loads

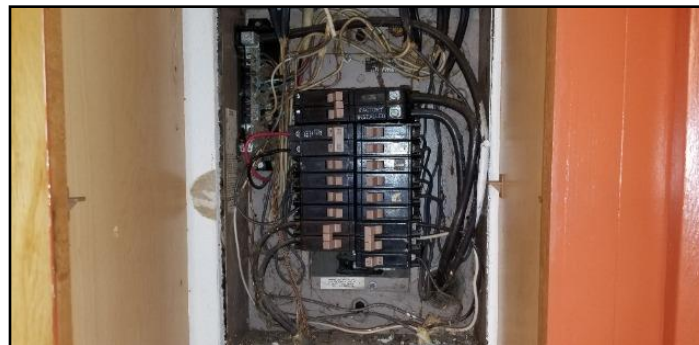
Poor access

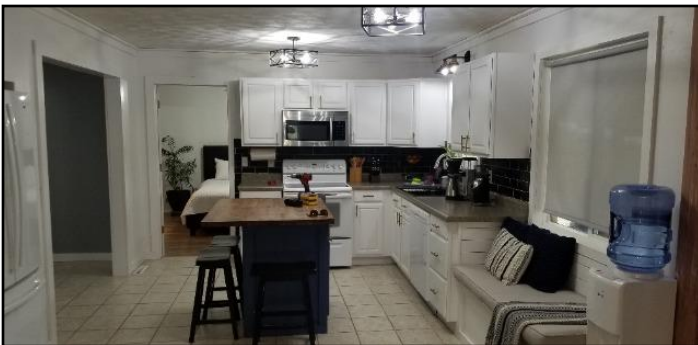
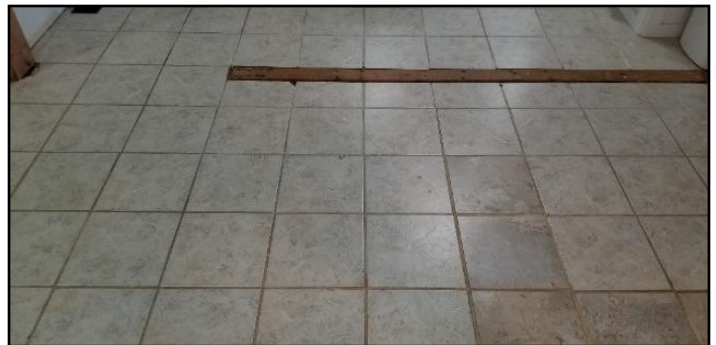
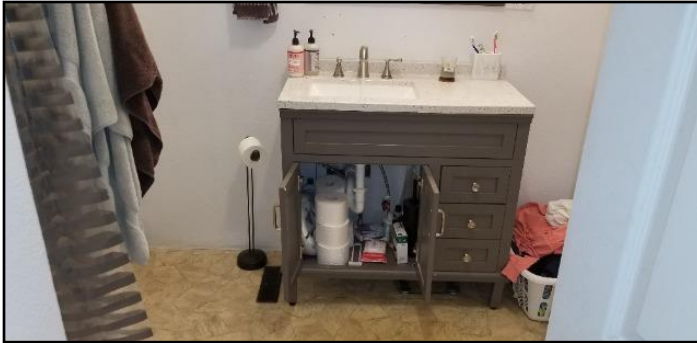
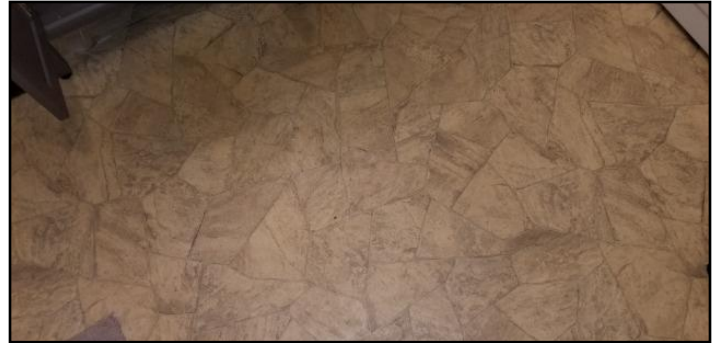
**Location:** Various

**Condition:** • Overall the interior doesn't look bad, it has a few typical flaws to be expected from use. And some residual light scuffing and damage from the remodel process. Acceptance of The finishes however are highly contingent on personal preferences.
